1st Nordic conference on Zero Emission and Plus Energy Buildings

# Energy performance evaluation of a nearly Zero Energy Building and the reasons for the performance gap between expected and actual building operation

**Evangelia Loukou<sup>1</sup>, Per K. Heiselberg<sup>1\*</sup>, Rasmus L. Jensen<sup>1</sup> and Hicham Johra<sup>1</sup>**

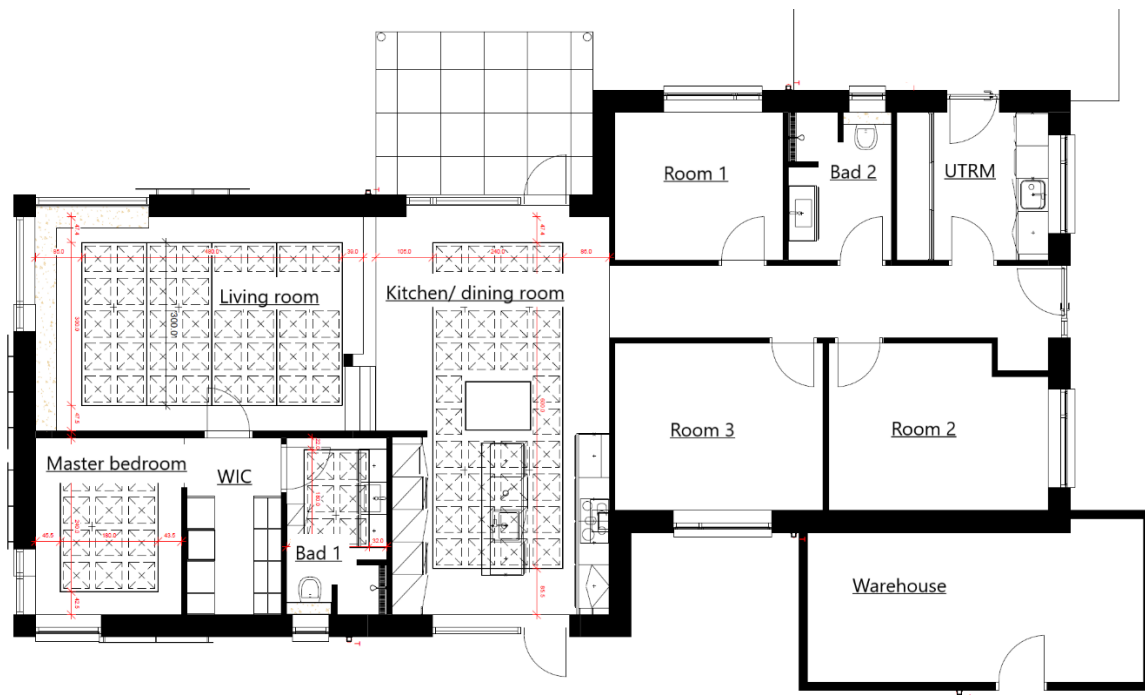
**Figure 1.** Floor plan of the study case.

The dwelling has a total floor area of 160 m<sup>2</sup>. It is constructed on two levels, with a height difference of 0.5 m. It includes 4 bedrooms, 2 bathrooms, 1 kitchen, 1 dining area, 1 living room, and a utility room. The kitchen, dining area and living room are connected to form an open space. There is also an unheated storage space attached to the building. There are windows towards all directions, while the openings in the South, East and West façades are equipped with sunscreens. Figure 1 shows the plan of the dwelling, while Figures 2 and 3 give an external view of the house.

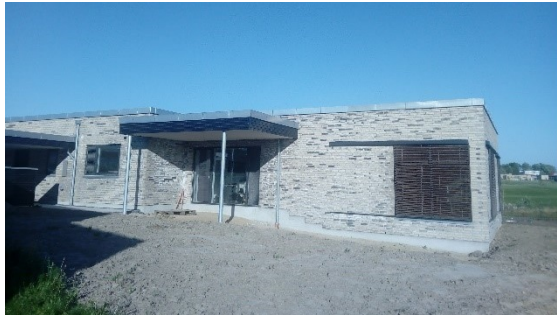
**Figure 2.** External northwest view.

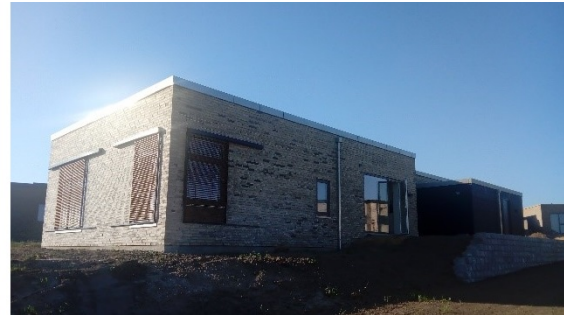
**Figure 3.** External south view.**Table 1.** Characteristics of the construction elements.

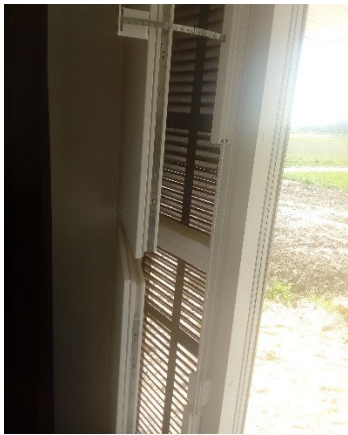
**Figure 4.** Ventilation louvers.

Natural ventilation and sun protection can be activated in order to create a pleasant indoor environment and minimize energy usage. Natural ventilation can be achieved through the skylights and a novel ventilation system with louvers incorporated in several windows in rooms with overheating risk. The external solar shadings are installed at the windows of the master bedroom and living room, with east, south and west orientations. In order to encourage the use of these systems, the solar shades are designed so that they allow good view to the outside, even when activated, while the ventilation louvers are providing theft and rain protection so that they can be used even when the dwelling is not occupied. In Figures 4 and 5 are shown the ventilation louvers and solar shades. At the end of November 2018, the natural ventilation and sun protection systems were connected to the control system, so that they can be

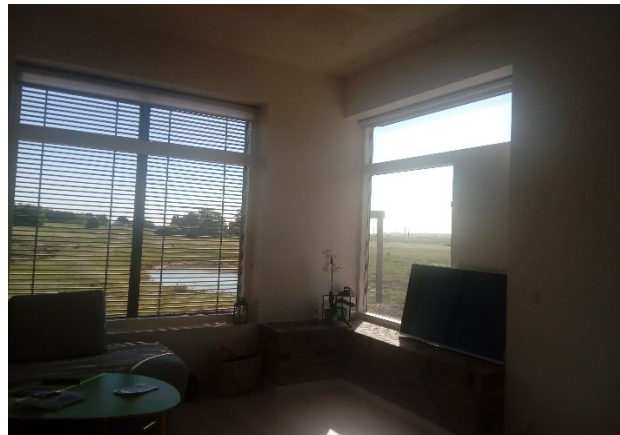
**Figure 5.** Solar shades and view to the outside.

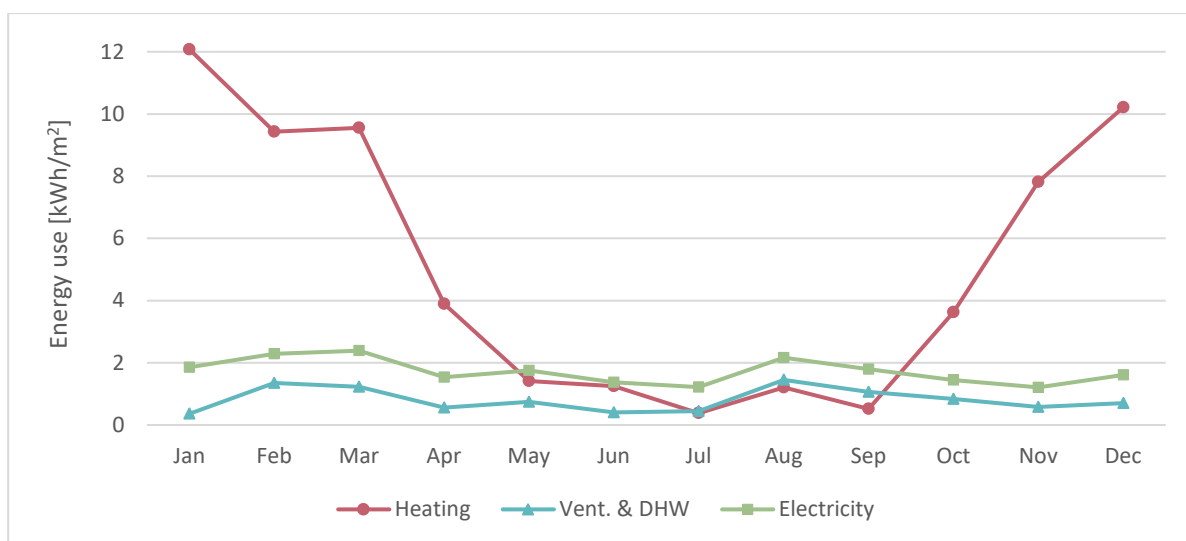
**Figure 6.** Energy use in 2018.

Through analysis of the monitored values, the energy needs of the building are assessed and the actual yearly energy use is compared to the expected one. Figure 6 presents the measured monthly delivered energy for heating, ventilation and production of sanitary hot water, as well as the total electricity use. The electricity use of the compact ventilation unit is shown both as part of the total electricity use and separately, as it accounts for 47% of the total amount. The rest of the electricity use is given by the white goods (cooking plate, refrigerator, dishwasher, cooker – for boiling water, washing machine and dryer), storage tank, floor heating pump, control system, and all the rest connected to the occupants' activities (household appliances and lighting). The white goods contribute to the total amount with 29%, the control system with 11%, and the storage tank and floor heating pump with 10.5%. A more detailed analysis of the electricity use by the different appliances can be found in the study of Carpino et al. [17], conducted for the same building.

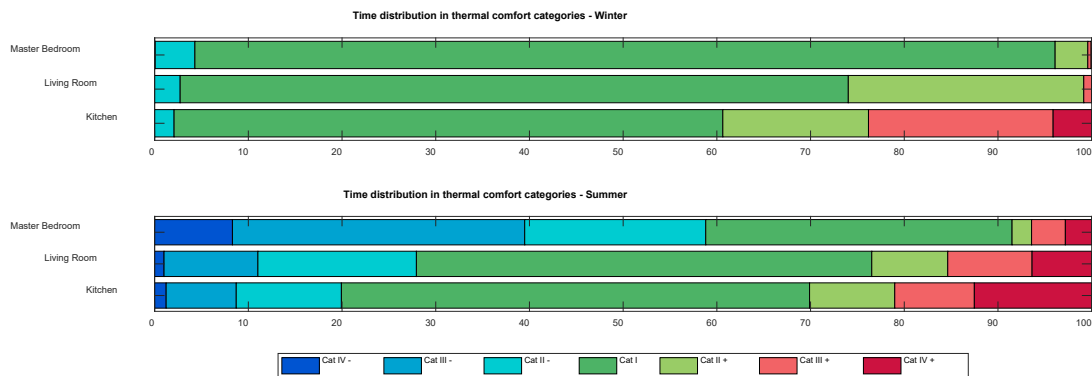
**Figure 7.** Time distribution in thermal comfort categories for winter and summer periods [%].

As one can observe in Table 5, thermal comfort remains in Category I and II during most of the time, with 77% and 85% for the bedroom and living room, respectively, while in the kitchen / dining room a percentage of 70% is achieved. In Figure 7, the aforementioned categories are divided into winter and summer period, in order to create a better visualization of the situation. It is worth mentioning that during

the heating period, the achieved thermal comfort level is very high. That is not exactly the case for the kitchen / dining area, where the large glazed areas towards the east and west can create a bit of overheating, even during the winter. Nevertheless, a decrease in the temperature set-point could be suggested, in order for the energy consumption for heating to be reduced. On the other hand, during summer, the temperature in the bedroom and living room seem to be quite low. It can be concluded that during the cooling season, the occupants prefer lower temperatures in the bedroom, which is probably achieved through the opening of windows at night time. Consequently, the temperatures in the living room and kitchen are also affected by these practices.
